FAILURES IN STEEL STRUCTURES : A COLLECTION OF CASE STUDIES

Surovi Ganguly

Senior General Manager, Tata Consulting Engineers Limited,
Sheriff Centre, 73/1 St. Marks Road Bangalore – 560001, India.
E-mail: surovig@tce.co.in

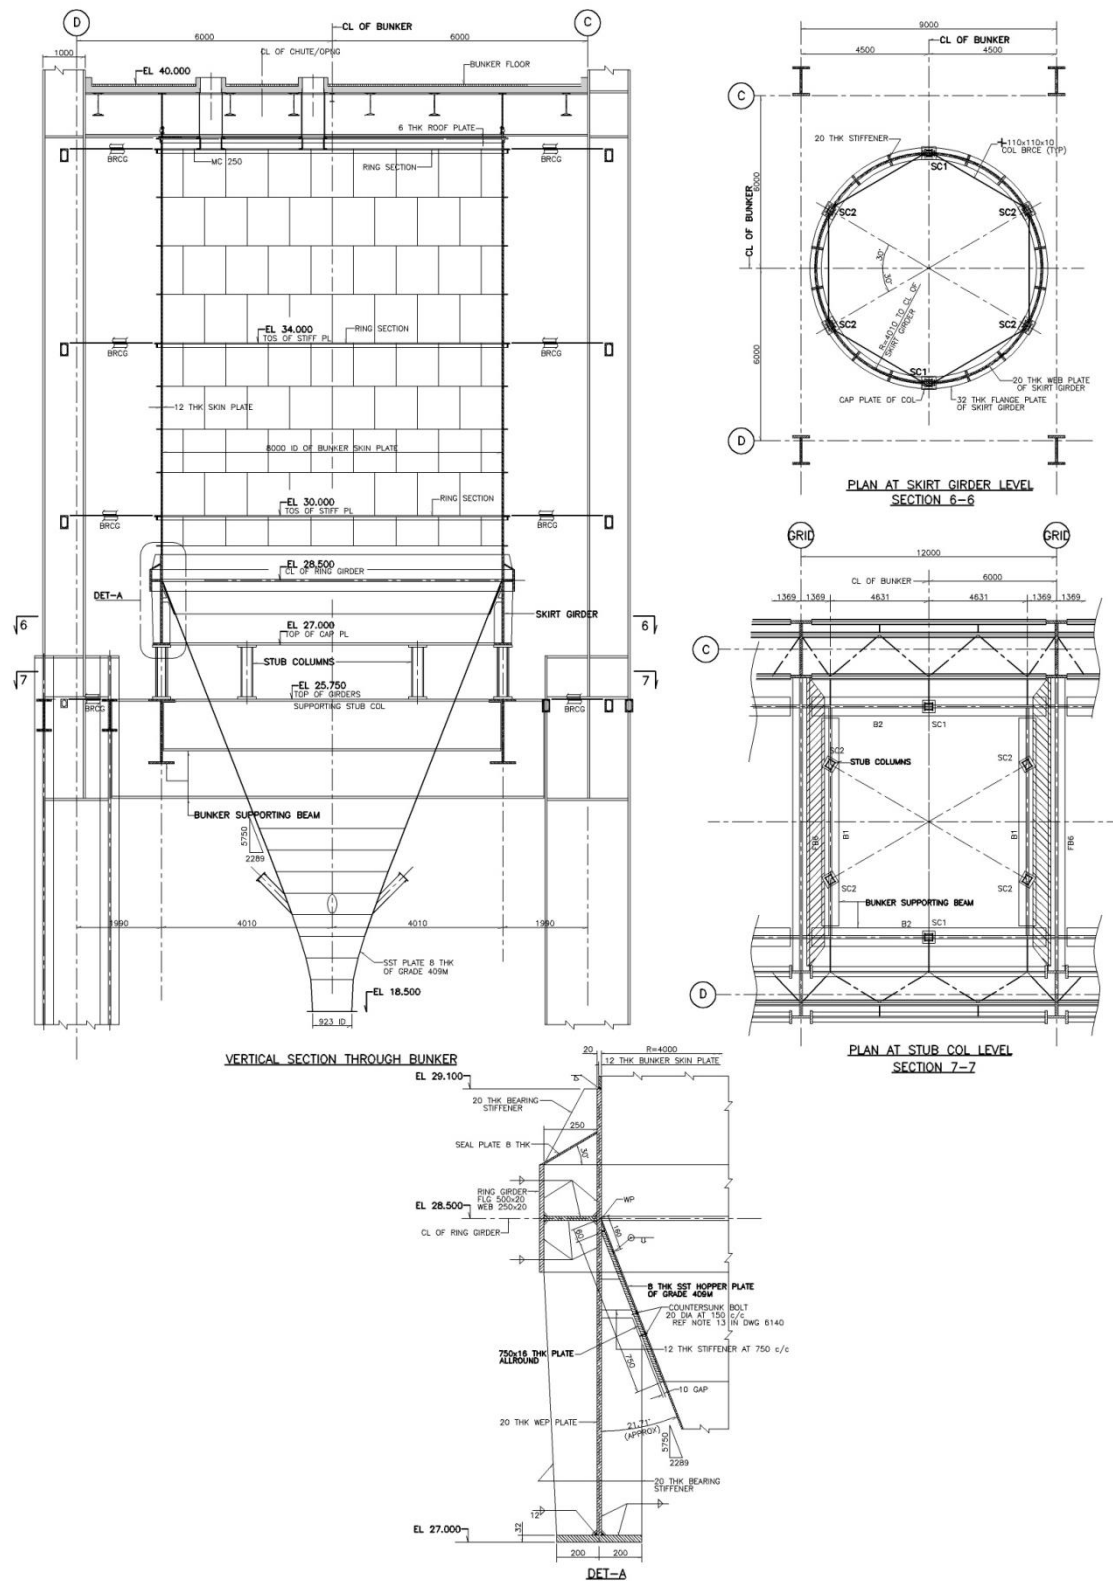
Figure 3: Structural Details of Coal Bunker

General arrangement and details of the bunker is shown in Figure 3. The bottom of the cylindrical portion of the bunker shell between EL 27.0m and EL 29.1m is fabricated from 20mm thick MS plates instead of 12mm MS Plates. At EL29.1m a horizontal flange of 400mm width and 32mm thickness is provided and welded to the 20mm cylindrical shell. The 20mm cylindrical web and the 32 mm flange form a skirt girder. The circular flange plate of the skirt girder is seated on 6 stub columns which rise from the mill and bunker building framing beams at EL 25.75m. These stub columns transfer the entire bunker vertical loads due to self weight and due to the weight of coal stored in the bunker to the Mill and bunker building through the framing beams at EL 25.75m. The top cylindrical portion of the bunkers is connected to the mill and bunker building framing at three elevations with plan bracings so as to transfer horizontal wind and seismic loads from the bunker to the building frames.

The conical bottom portion of the bunker is welded to the 20mm cylindrical shell internally at EL 28.5m. Externally at this elevation a T shaped ring beam is welded to the cylindrical shell. As the bunker is around 20m in height and 8m in diameter, single piece erection of the bunker would be difficult. The bunker was to be erected in two pieces - Cylindrical shell first and hopper portion next. To help with the site erection of the bottom conical portion or the hopper, a circular sloping 16mm thick plate, 750mm wide and whose slope matches the slope of the hopper is shop welded to the inside bottom portion of the cylindrical shell. This sloping annular plate acts as a seating bracket plate for the hopper shell to be placed on after lowering from top through the cylindrical shell and then held in position during erection till the hopper can be site butt welded to the top cylindrical portion of the bunker. The topmost piece of the SS conical hopper shell which is around 160mm wide, 8mm thick is shop welded to the cylindrical shell just above the seating plate. This is done so that the top diameter of the loose conical shell piece which has to be site erected by lowering through the top cylindrical shell can be less than 8m, which is the diameter of the cylindrical shell, and so that the hopper can be easily lowered through the cylindrical shell. The conical shell piece is site butt welded to this top 160mm wide piece of the conical shell plate. The seating plate will also act as a backing strip for this weld. This weld is a very important weld and needs to be carried out carefully and has to be radiographically tested to ensure its strength, as the entire hopper load gets transferred to the skirt girder through this weld. In other words the hopper actually hangs from the skirt girder through this weld.

During the site visit it was noted that the conical hopper portion of the bunker was found detached from the top cylindrical portion of the bunker at the location of the square groove field butt weld that was carried out between the two SS 8mm hopper plates. It was also noted that the MS 16mm thick seating plate and the top 160mm wide SS 8mm thick plate were found intact and welded to the cylindrical portion of the bunker after the failure. During the site visit it was also noted that the top portion of the conical hopper had vertical cut marks that were welded. After discussion with the site engineers, it was established that the contractor had erected the conical hopper portion from bottom and not from top. While following this erection procedure it was difficult to push in the larger diameter of the conical shell into the smaller diameter of the seating plate that had come shop welded to the inside of the cylindrical portion of the bunker. Hence the contractor had vertically cut the top of the conical hopper at a few locations and crimped the conical shell at top so as to push the conical shell inside the annular bracket plate. Later the conical shell was opened and welded. This resulted in the conical shell not sitting properly on the seating plates and thereby not properly aligning to the top 160mm wide SS plate. The contractor most likely would have held the bunker conical piece from below and then would have carried out the square butt weld between the two unaligned shell pieces. There would have been gaps between the seating plate and the conical shell. This was observed at site for the other bunkers that had not failed by the team of engineers that visited site after the failure of the first bunker. Due to this gap, carrying out the square butt weld

would have been very difficult as the backing strip which was the seating plate was not in position. Due to this faulty welding the weld had given way and the conical portion got detached from the cylindrical portion.

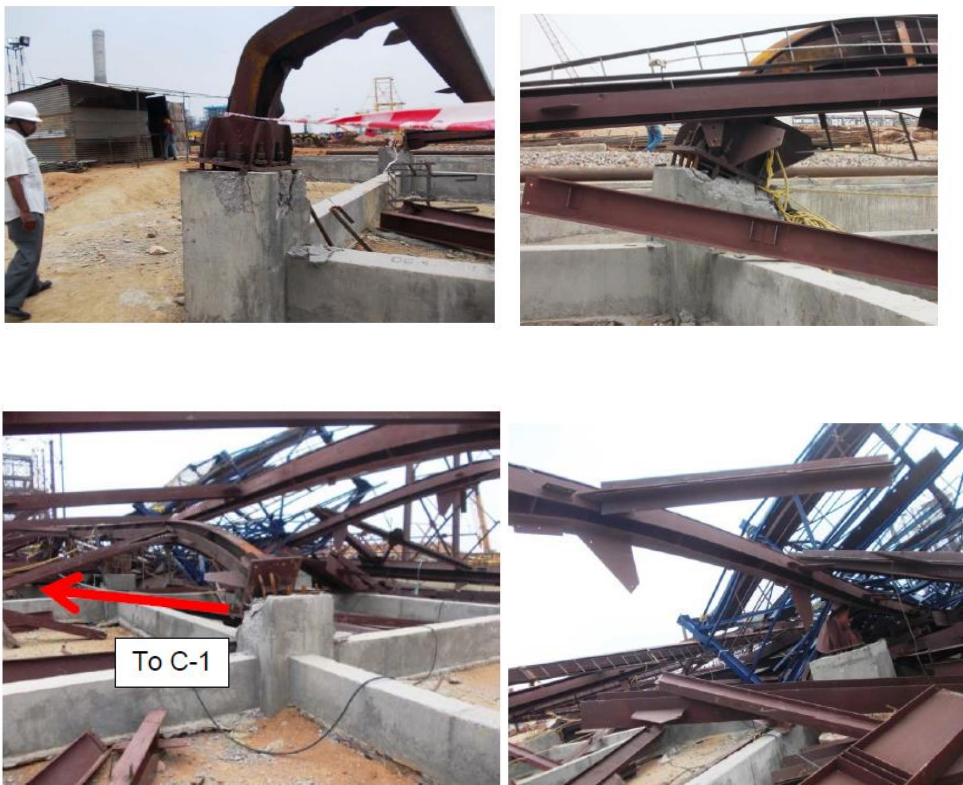
During a site visit after the collapse the team of engineers noticed that one of the collapsed junction towers had been erected with only the top level vertical bracings between the tower columns in position. The lower level bracings were not connected to the tower columns. The various floors of the tower were erected along with the first span of conveyor gallery supported on the junction tower. The tower was nearly complete except for lower level bracings and some minor works. During the winds as there was no path for the wind forces to reach ground / foundation level, the wind forces had bent the columns and the whole tower had come down. The anchor bolts connecting the steel columns to the concrete foundation pedestals were badly damaged and cracks were observed in the top portion of concrete pedestals around the bolts. Some pedestals were even found crushed below base plate.

The second tower that had collapsed was erected with columns and floor beams in position but with no vertical bracings erected. The un-braced columns were not guyed also. Hence during winds the columns got bent and collapsed and fell on the adjacent erected trestle and damaged it also.

Junction towers have columns which are vertically braced from top to bottom of the tower. The bracings give lateral support to the tower columns and provide a path for horizontal forces due to wind/ earthquake/ equipment acting at various levels of the tower to reach the foundation level by inducing axial forces in the bracing/ column system thereby giving a light effective structural system. If the bracings are not provided at any level, the horizontal forces will induce bending in the columns instead of axial tension/ compression. The columns are not designed for bending and will fail under such conditions. Due to bending induced in the columns there could be bending tensions induced in anchor bolts connecting the steel columns to the foundation pedestals and which may fail by cracking/ crushing the pedestal concrete. The following erection scheme should be followed:-

SITE PHOTOS OF CRUSHED FOUNDATION PEDESTALS AND OF COLUMNS ERECTED WITHOUT BRACINGS

- The columns are erected first and held in position and guyed.
- The bracings are erected.

- The tower columns are checked for verticality and anchor bolts are tightened.
- Only after this is completed, the other elements like floor beams/ flooring/ conveyor galleries / any other loads are erected on the tower.
