FAILURES IN STEEL STRUCTURES : A COLLECTION OF CASE STUDIES

Surovi Ganguly

Senior General Manager, Tata Consulting Engineers Limited,
Sheriff Centre, 73/1 St. Marks Road Bangalore – 560001, India.
E-mail: surovig@tce.co.in

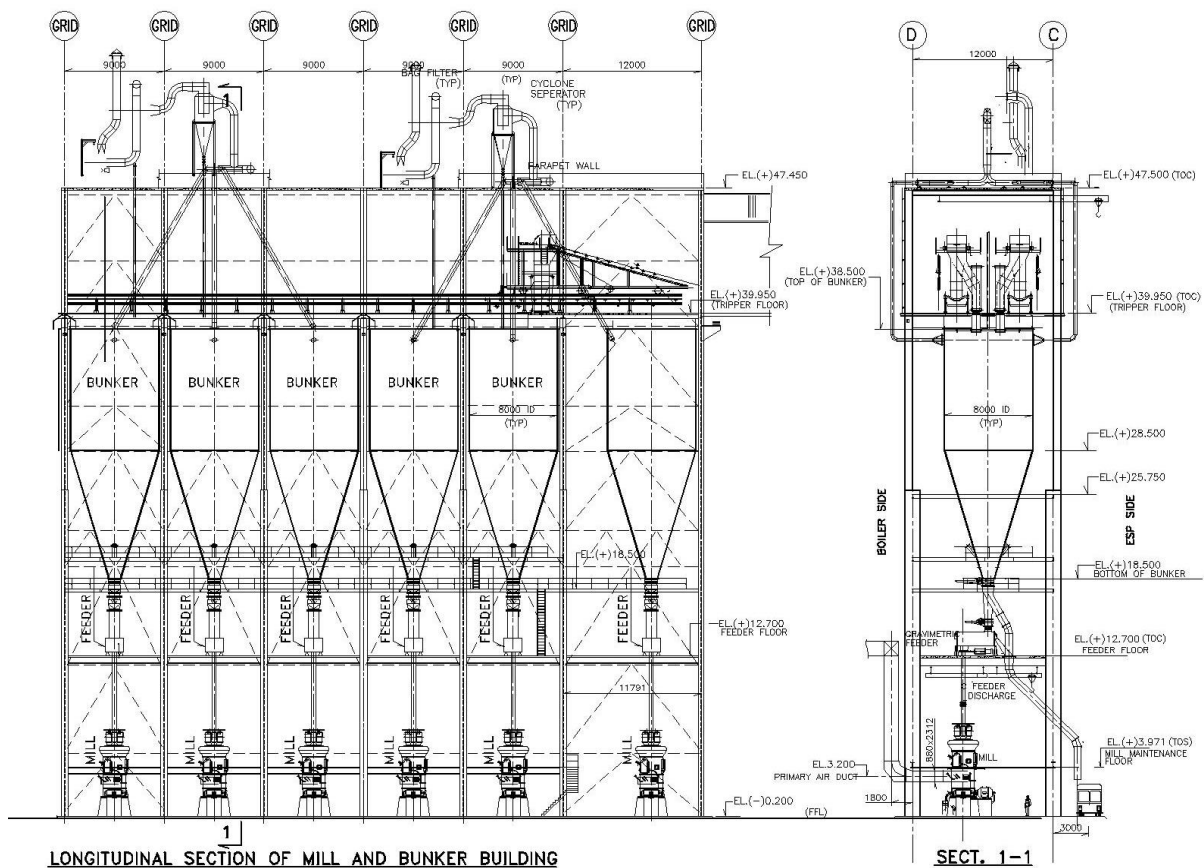
Figure 1: General Arrangement of Mill and Bunker Building

The mill and bunker building (Figure 1) which houses the bunkers is a structural steel building 12m wide, 47.5m high and 57m long. This building has portal frames in the transverse direction at 9m centers with last frame at 12m centers. Each portal frame has two columns along grids C and D at 12m centers. All the columns along grids C and D are vertically braced. The building has two major RCC floors and a RCC roof. The RCC floors and roof are cast on structural steel floor beams. The floor at EL 12.7m is the feeder floor which supports the gravimetric feeders. Coal stored in the bunkers above this floor is taken to the mills below through the gravimetric feeders. At EL 39.95m is the Tripper floor. Coal is dropped into the bunkers placed below the tripper floor with the help of coal trippers that move on this floor. The roof for this building is at EL 47.5m. The Mill and bunker building also has structural steel floor framing beams at EL 25.75m which is the bunker supporting floor.
