Steam Audit: A case study

By Bharat Yadav

Here is a case study of steam audit of a typical Oil Refinery done by TCE

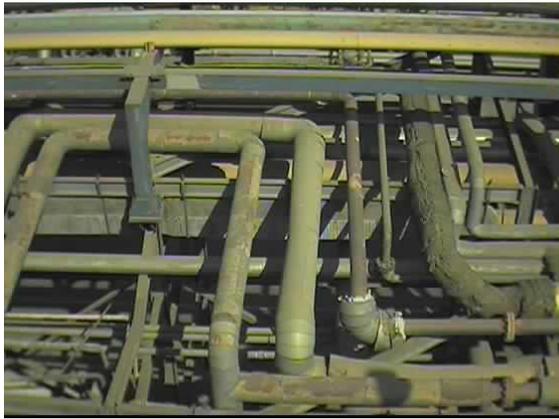
- a) Thermal Insulation Survey of Main distribution Header (HP, MP, LP) & Main header inside the Process Units of entire refinery
- b) Heat loss measurement was done during dry as well as rainy season
- c) Sample observation of Thermal Insulation survey is indicated in Figure-1 & 2 below.

Figure 1: Visual appearance Photo

- d) Steam System related items with damaged/poor insulation as well as bare surface were identified.
- e) Area required to be thermally insulated was quantified for bare and poorly insulated pipe, Pumps, Valves, bends, flanges.
- f) Total Steam Loss (~60 TPD) due to poor Insulation was quantified
- g) Cost of steam loss was quantified
- h) Suggestions to improve Insulation were made
- i) Payback Analysis was done
- j) Vendor of Insulating Material were indicated

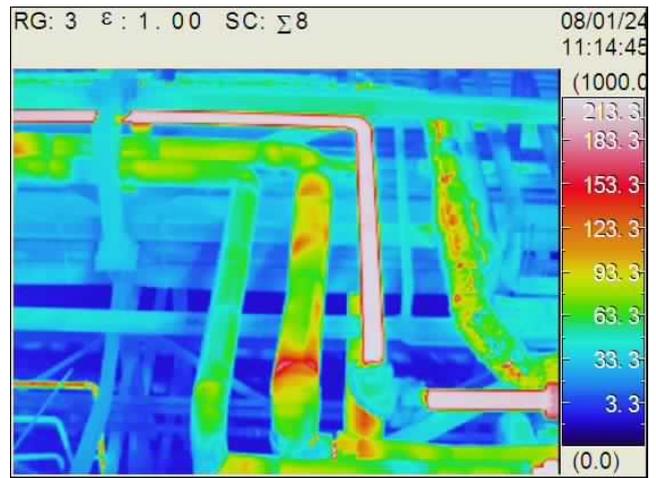
Figure 2: Thermal Image
